HOME INSPECTIONS PLLC

SAMPLE REPORT

PROPERTY INSPECTION REPORT FORM

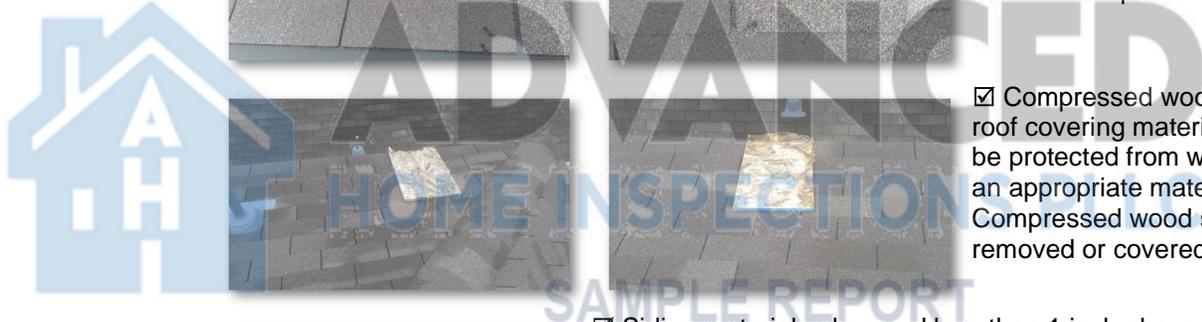
☑ Aggregate loss observed on several shingles.

☑ Physical damage to shingles observed at several places. A qualified roofing contractor should be consulted to determine repairs.

☑ Siding materials observed less than 1 inch above roof covering materials in several places. Siding materials should be separated by at least 1 inch to prevent moisture being trapped between the roof covering and the siding.

☑ Ridge cap shingles appear to have lifted or not secured properly. Ridge cap shingles should be secured to prevent wind uplift.

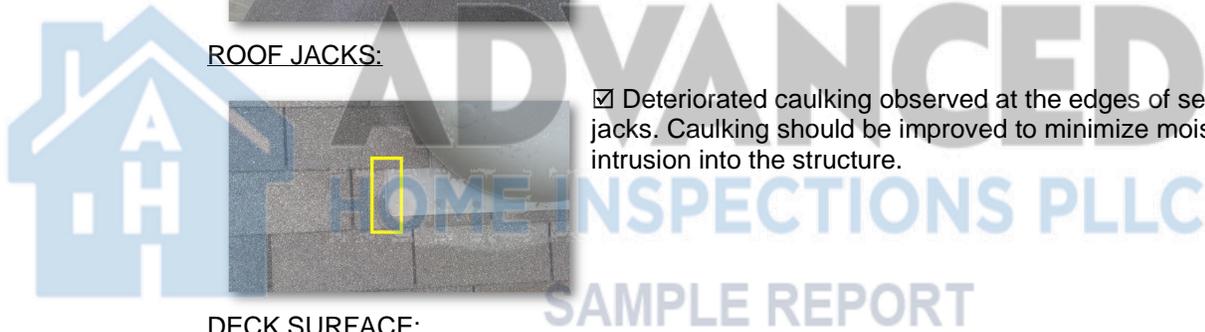
☑ Roof to wall flashing missing on the front right side. Flashing helps prevent moisture intrusion into the structure.

☑ Deteriorated caulking observed at the edges of several roof jacks. Caulking should be improved to minimize moisture intrusion into the structure.

☑ Steps in the deck surface should be investigated by the builder to determine the cause. Limited access to the underside of this area prevented any evaluation.

☑ Drip edge flashing requires 2 inches of overlap. Some areas were observed where the overlap is less than 2 inches.

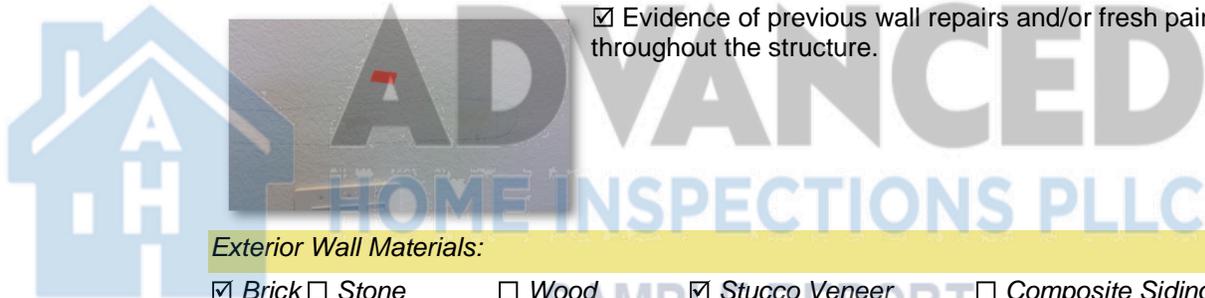
Wall trim caulking should be improved to minimize conditioned air loss.

Holes in the walls for pipes should leave no more than 1/4 inch gap around the pipe to prevent pest intrusion and conditioned air loss. Conditioned air can condense in wall cavities.

Wall trim caulking including stair to wall trim caulking should be improved to minimize conditioned air loss.

Evidence of previous wall repairs and/or fresh paint observed throughout the structure.

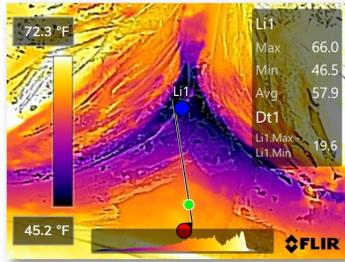
Temperature differences and patterns associated with conditioned air leakage observed when using the thermal camera on the plenum.
